MONTGOMERY COUNTY FIRE AND RESCUE SERVICE
MONTGOMERY COUNTY, MD.

INFORMATION BULLETIN

NUMBER: 14-09
December 2, 2014

Deployment of Airbags and Related Components

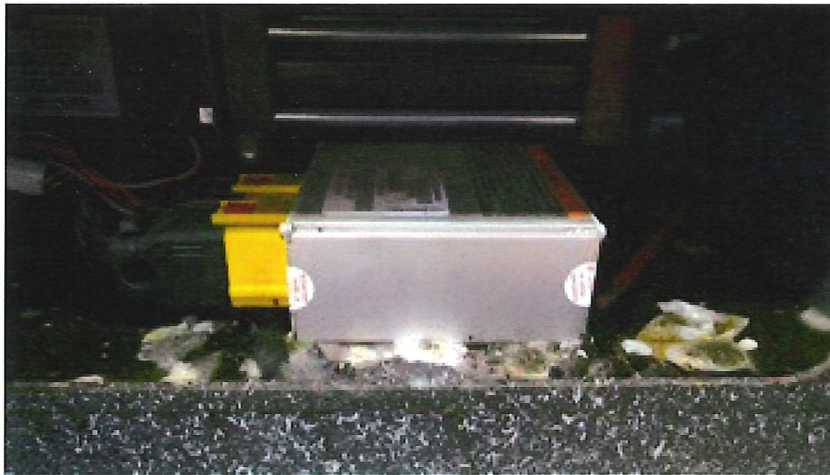
At this point, it is generally agreed that a liquid was spilled into the area underneath the officer's seat. This is where one of the two sensors is located. The liquid had been there for some time and damaged the sensor. This is the probable cause of the deployment. How did the liquid get there? It is likely that someone placed a drink behind the officer's seat and that it spilled into the space where the seatbelt pre-tensioners operate. This was likely a one-time event and not a widespread failure of the crew protection system.

Pictures are attached of a) the contamination found under the officer's seat on RE1 and b) of an activated SRS light.

- **STATIONS**
 - Be careful where liquids are placed inside the cab.
 - Ensure that when the morning checkout occurs, or at any other time of the day, when the ignition is turned on, the SRS (supplemental restraint system) light activates for 5-10 seconds before going out.
 - If the SRS light does NOT illuminate at ignition OR the SRS light activates during the normal course of operations, please enter a defect report.
These situations, however, are not out-of-service conditions.

- When an engine is out for a PM, the SRS light will be inspected and the area under the driver's and officer's seats will be inspected for damage to the sensors.
